MAGNIFICENT WINDOWS RESTORED AT DOMINGUEZ SEMINARY

THE ARTISTIC CHALLENGES OF STAINED GLASS RESTORATION

STAINED GLASS CEILING FEATURED IN STAINED GLASS QUARTERLY

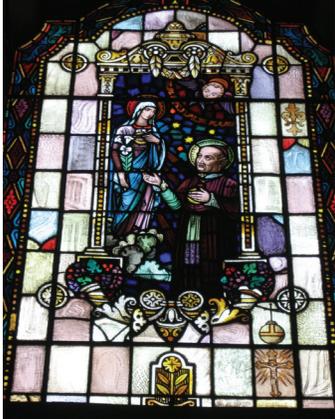
South Window, Chapel, Claretian Missionaries, Rancho Dominguez, California. The large center section, 43" x 63" depicting St. Anthony Claret with the Blessed Virgin Mary and the section below this, 43" x 21" were completely re-leaded.

Three sections of the stained glass were significantly bowing and sagging. These sections were removed to our studio for complete re-leading. The original stained glass artisans used six different sizes of lead, an unusually high number. In some areas, the different sizes helped define or emphasize elements of the design; in other areas, different leads were needed to accommodate some unusually thick pieces of stained glass. Identifying and replacing as closely as possible the different lead sizes was one of the most interesting challenges of the work. For more photos and information, follow this link to our website: <http://AncientArtsStainedGlass.com/press110911.html>.

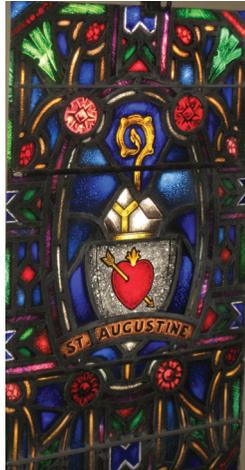
The broken panel after restoration and reinstallation at Immaculate Heart of Mary

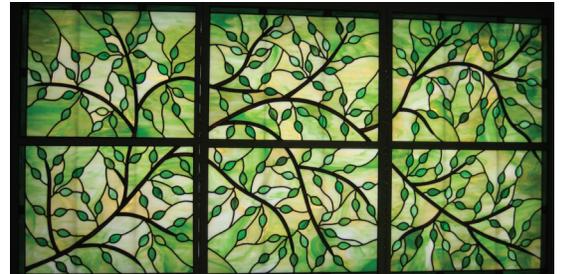
Stained Glass Ceiling, Private Residence, Rancho Palos Verdes, CA, 2011

The ceiling panel, installed below a skylight is approximately 8' x 4' and is in the entry hall of a private residence in Rancho Palos Verdes, California. The design challenge involved picking up on the decorative metal artwork that has been featured on the homeowner's fireplace for many decades. For more information, go to <http://AncientArtsStainedGlass.com/press011413.html>.
